FINAL REPORT OF SPECIFIC PURPOSE LIDAR SURVEY

LiDAR, Breaklines and Contours for Dixie County, Florida

State of Florida
Division of Emergency Management
Contract 07-HS-34-14-00-22-469
Task Order 20070525-492718a
PDS Task Order B

October 30, 2009

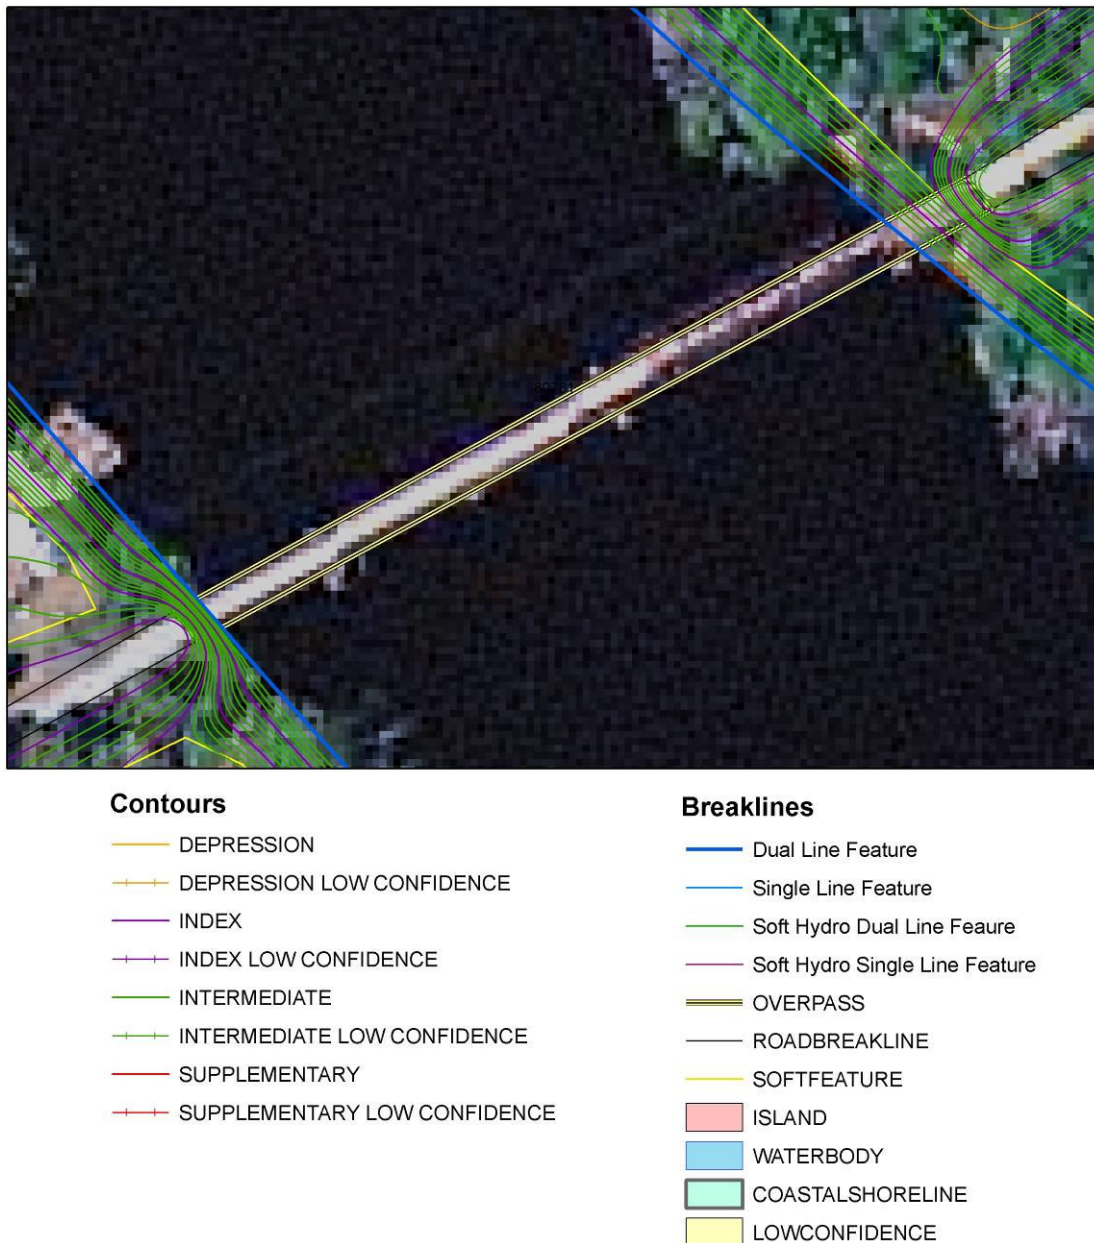
Bridges and overpasses are correctly captured as three-dimensional breaklines, capturing the edge of pavement on the bridge, rather than the elevation of guard rails or other bridge surfaces. Each vertex maintains vertical integrity. Figure 5 shows example breaklines and contours of bridge and overpass features.

Figure 5. Example bridge and overpass feature breaklines and contours from tile # 80781

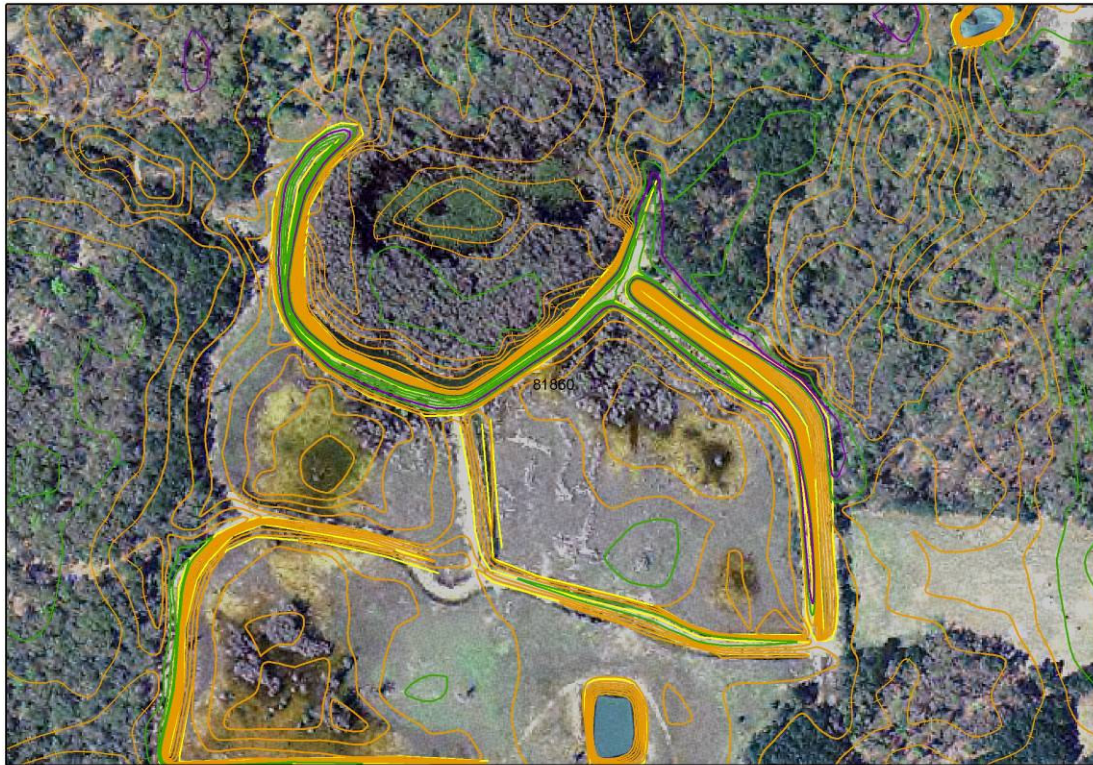
Soft features such as ridges, valleys, top of banks, etc. are correctly captured as three-dimensional breaklines so as to support better hydrological modeling of the LiDAR data and contours. Each vertex maintains vertical integrity. Figure 6 shows example breaklines and contours of soft features.

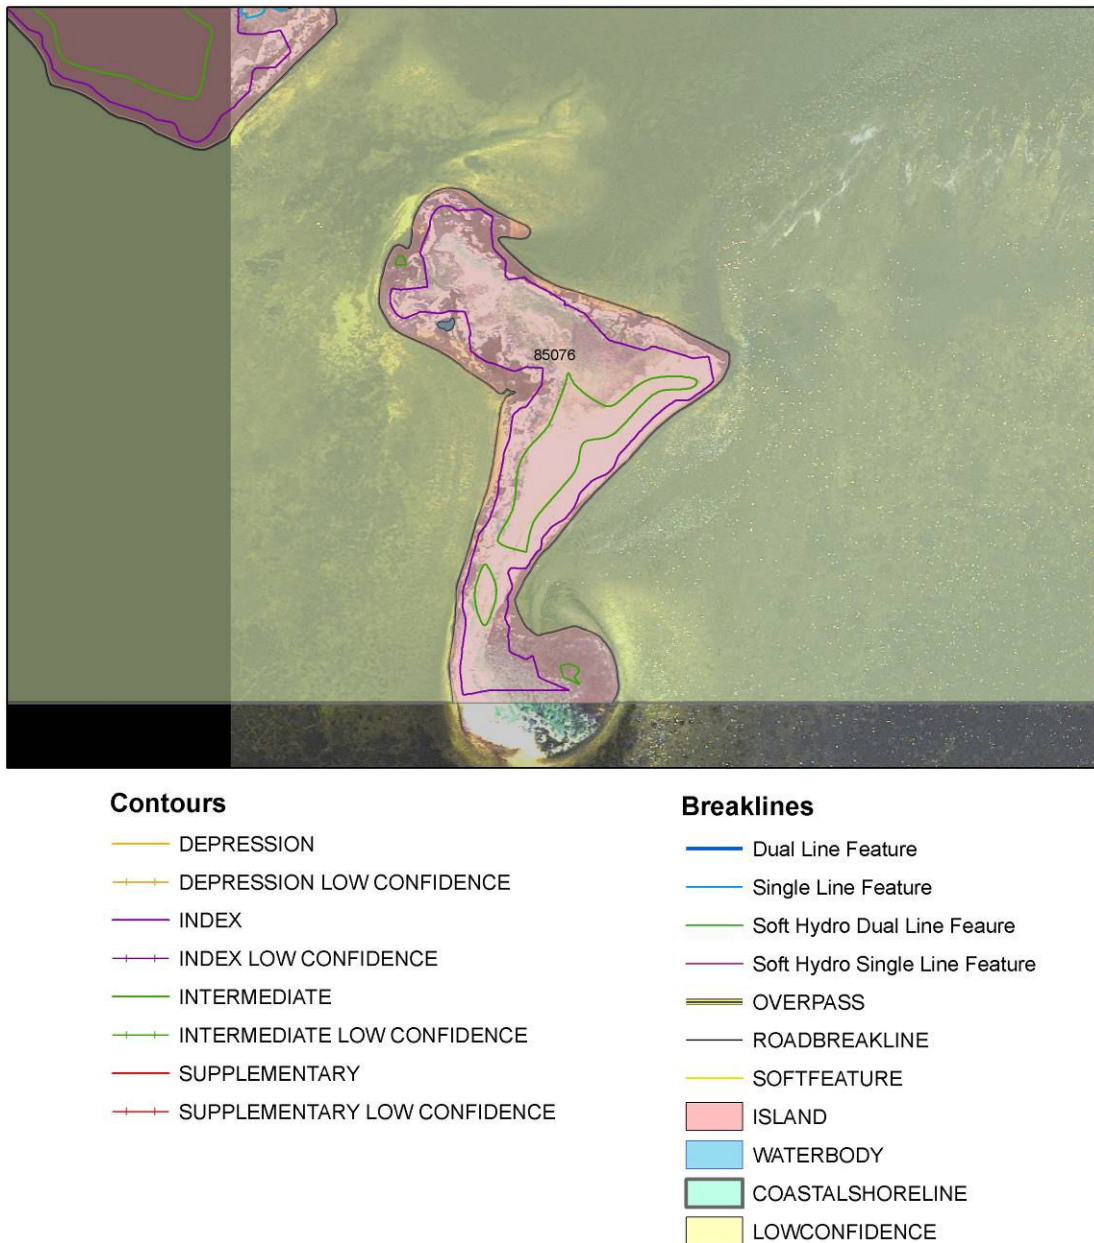
The shoreline of islands within water bodies are correctly captured as two-dimensional breaklines in coastal and/or tidally influenced areas and as three-dimensional breaklines in non-tidally influenced areas for island features one-half acre in size or greater. All natural and man-made islands are depicted as closed polygons with constant elevation. Figure 7 shows example breaklines and contours for island features.

Figure 7. Example island feature breaklines and contours from tile #85076

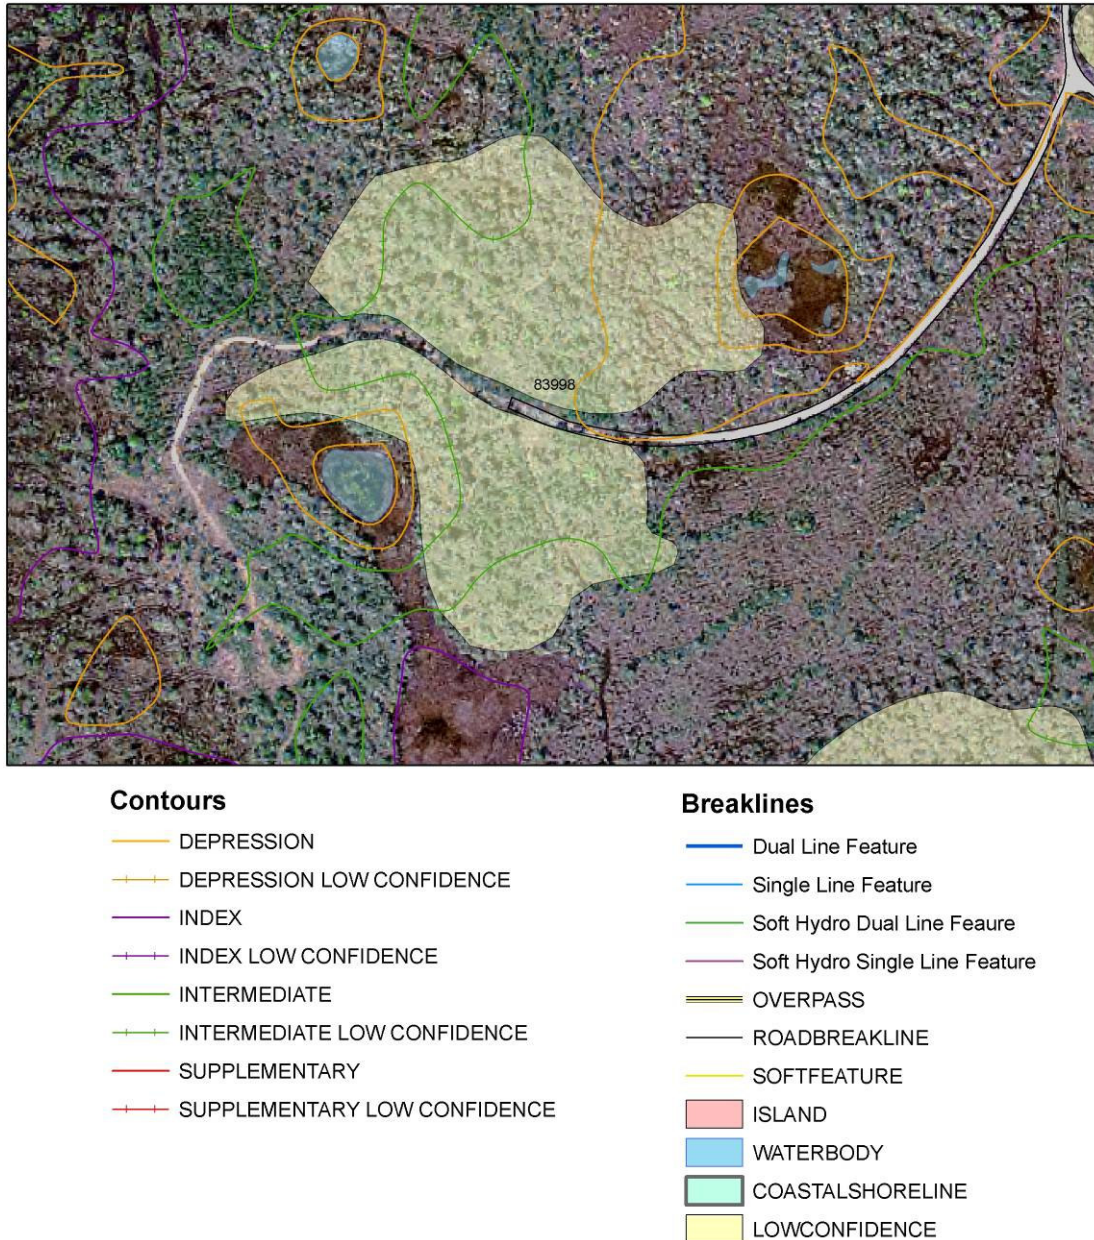
The apparent boundary of vegetated areas (1/2 acre or larger) that are considered obscured to the extent that adequate vertical data cannot be clearly determined to accurately define the DTM are correctly captured as two-dimensional features with no z-values. Figure 8 shows example breaklines and contours for low confidence areas.

Figure 8. Example low confidence area feature breaklines and contours from tile #83998
